Newtown Creek Aeration System

August 30, 2021

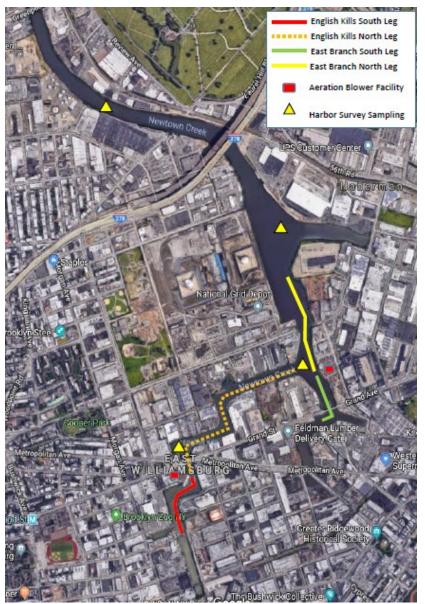
Background

- DEP deployed diffused aeration to improve dissolved oxygen (DO) levels in Newtown Creek.
- Two in-Creek aeration systems
 - English Kills (orange and red) 2014
 - East Branch (yellow and green) 2018
- Target DO level of 3 mg/L (95% of the time)
- DO drivers
- Seasonal Operation
 - May 15 Sept. 30, bi-weekly sampling
 - 2019 Modified: June 15 Sept. 30, weekly sampling

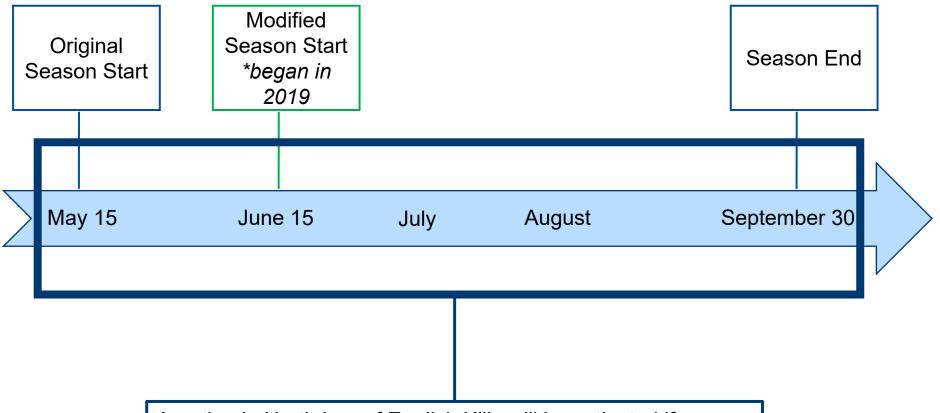
Augmented Monitoring Program Triggers

Aeration in North Leg of English Kills will be activated if:

One Harbor Survey sample finds DO levels below 3.0mg/L

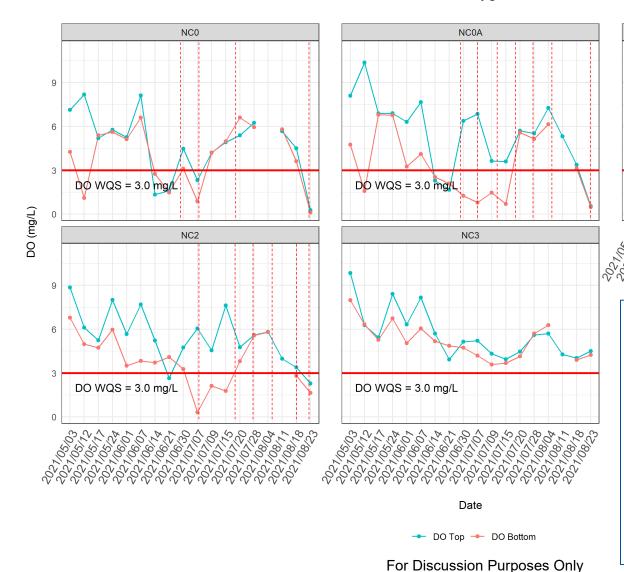
Dissolved Oxygen 2021

The system has worked to eliminate instances of low DO.

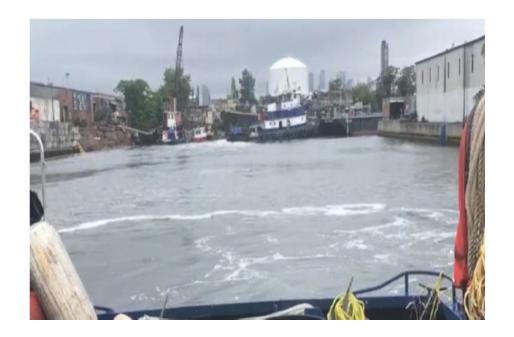
- New contract dedicated to NC aeration lines
 - 3-year contract, \$ 687,995.00
 - Start date: 4/8/2019
- Summary Repairs:
 - Repaired the 6-inch flange connections on East Branch.
 - Repaired broken diffusers Assisted with the blower issues at both English Kills and East Branch.
 - Replaced broken diffusers at the north end of English Kills.

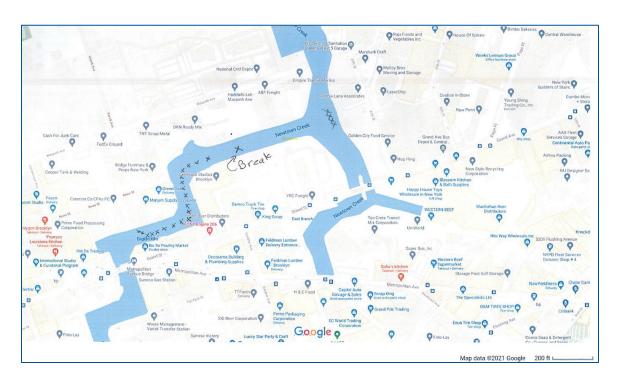
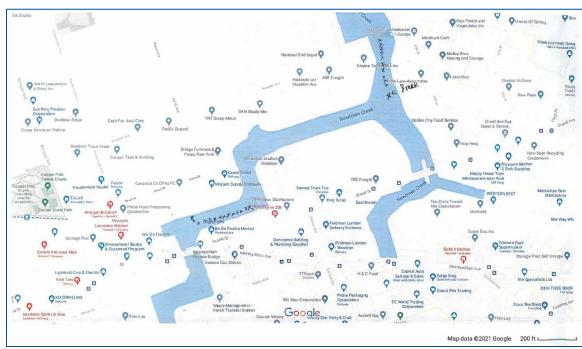
System Repairs System Line Diffusers and Breaks

7/20/2021 8/18/2021
